Song Loulou Dam

Detailed Concrete Diagnostics

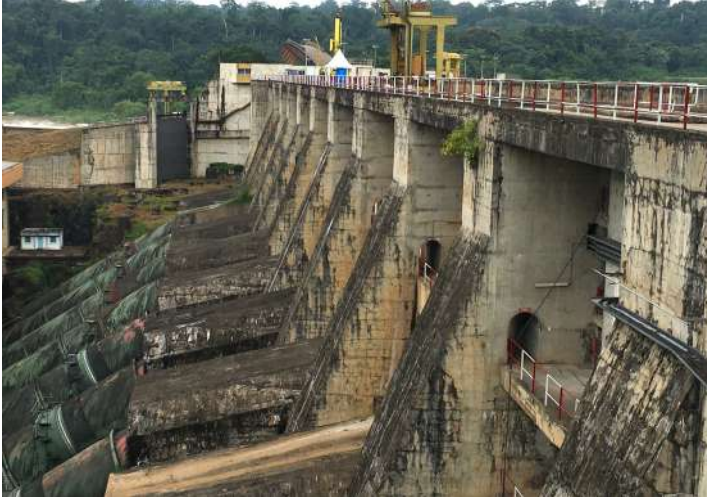
General View

The dam is showing age-related signs of deterioration with cracks affecting the spillways and buttresses. Sixense was commissioned by ENOE to determine the origin of these cracks and provide specialist advice on possible future degradation of the structure.

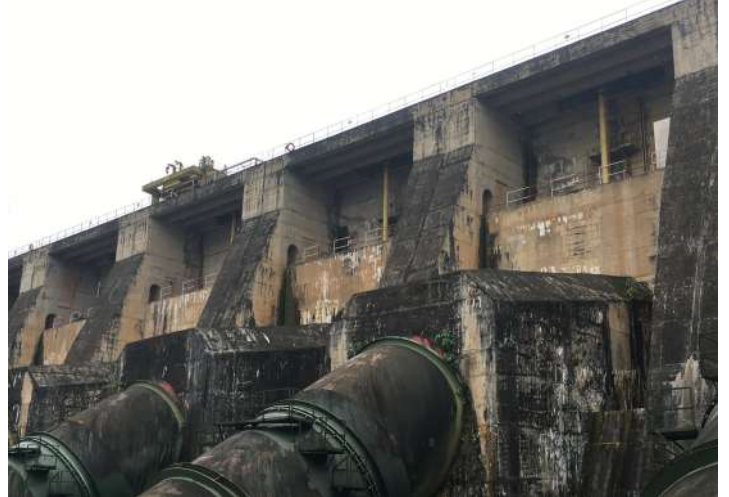
Cracked Concrete Siding
