Cherokee and Douglas dams

Deformation monitoring during structural modifications for PMF (Probable Maximum Flood) and Seismic Loadings

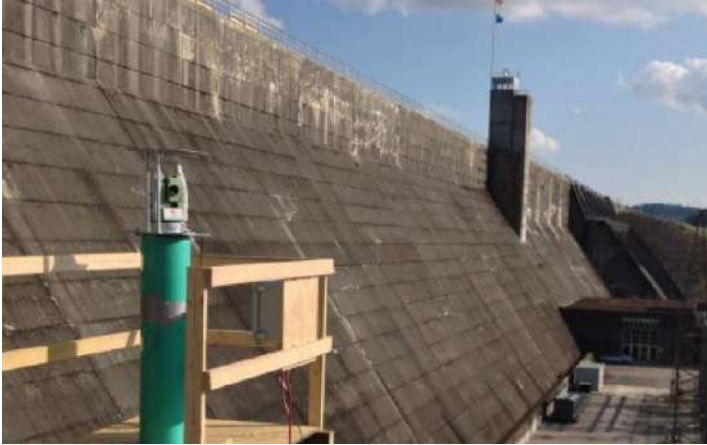
AMTS at Cherokee Non-overflow Zone

The main challenge of the monitoring task was the high precision requirements. At first, a manual survey solution was evaluated. However, an Automated Data Acquisition System (AMTS) was proposed by SIXENSE and accepted by the TVA.

The AMTS system provided a near real time monitoring solution for both dams with accuracy of x,y,z coordinates between 1-3mm within 300'-400' of target prism to AMTS.
